Mast and Rigging Inspection Report

Yacht name: Bilbo

Yacht type: Dufor 38

Date of inspection: 1/11/16 **Inspection number:** 0122/1

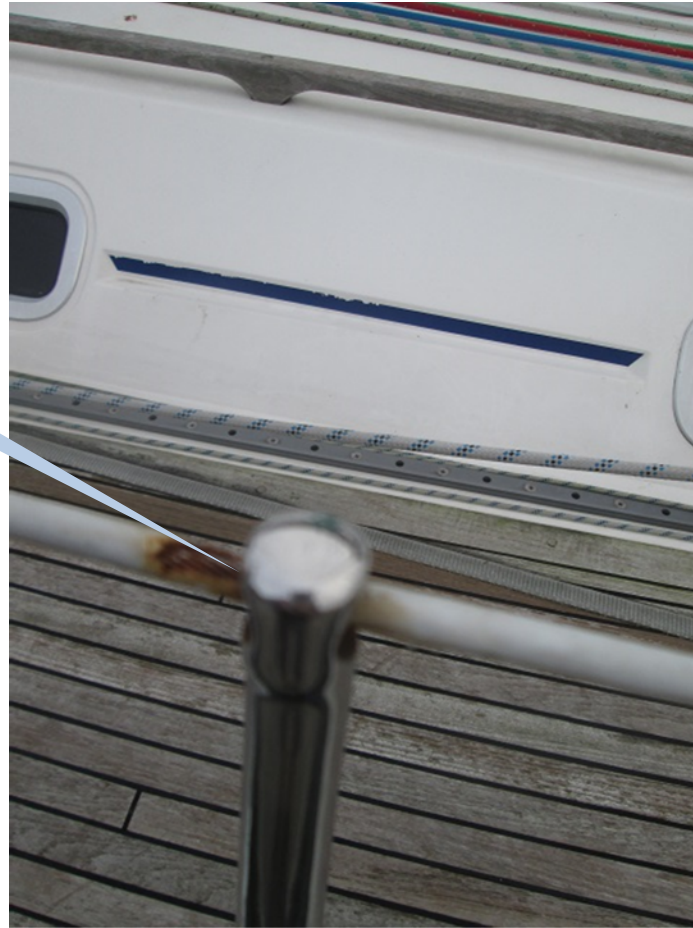
Guard wires worn
through stanchion

The report findings show items of wear that should be addressed to prevent component failure. The age of the standing rigging is not gauged, built if it is known to be ten years old, or older, our recommendation is to replace it. The guard wires should be renewed with uncovered 1x19 stainless steel wire.

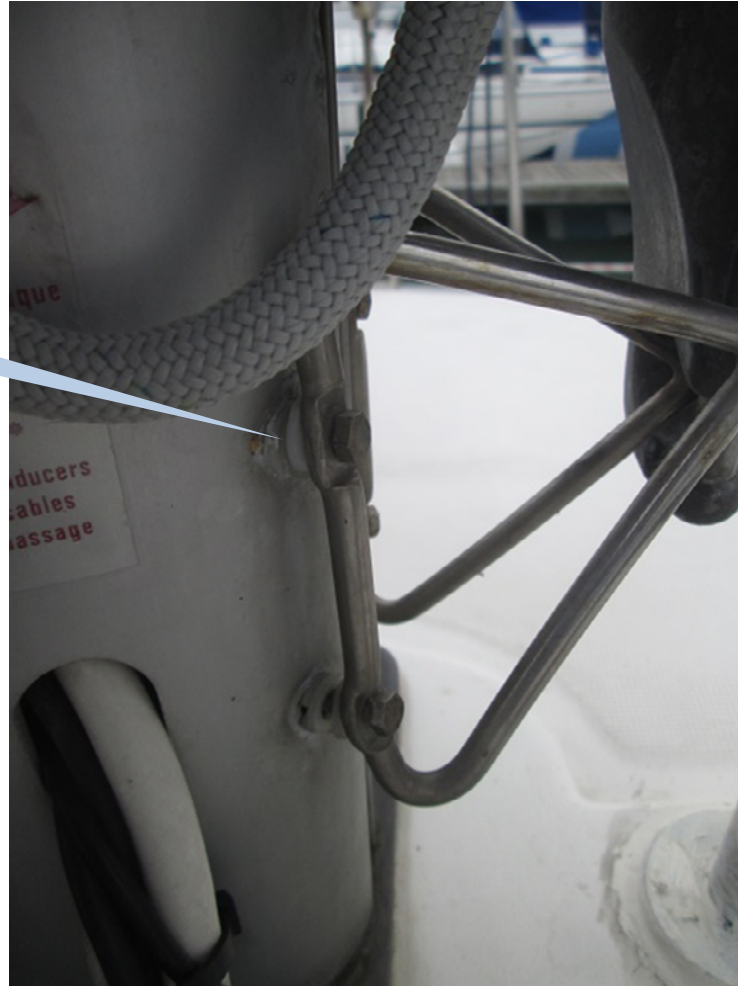
Pole stowage
bracket fastenings
unsecured

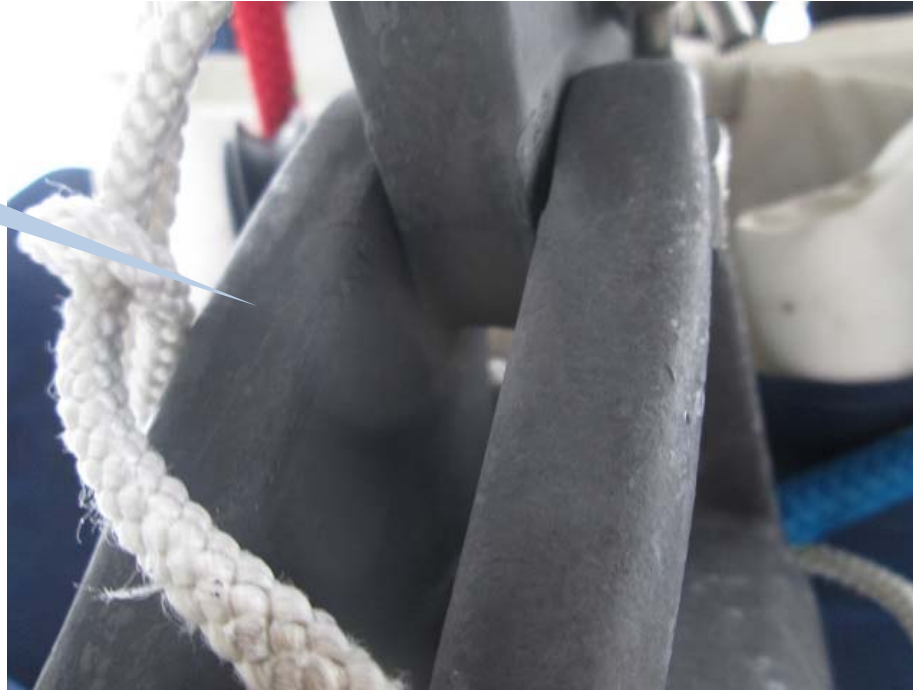
Wear to gooseneck
toggle

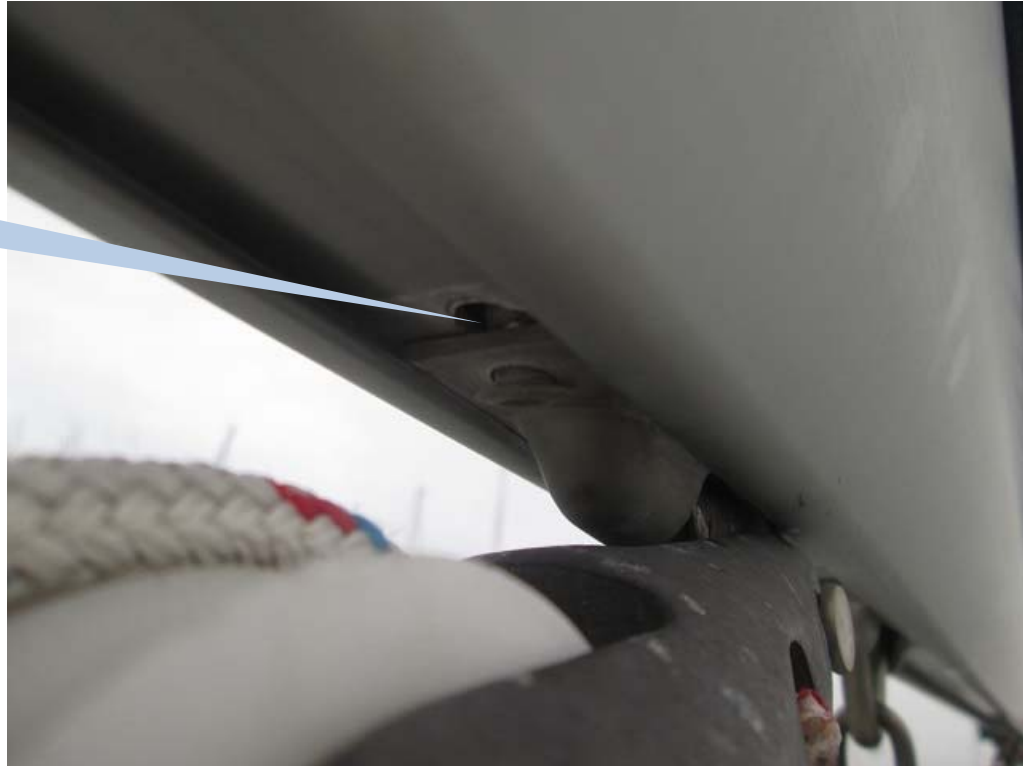
Vang lug securing
rivets pulling out

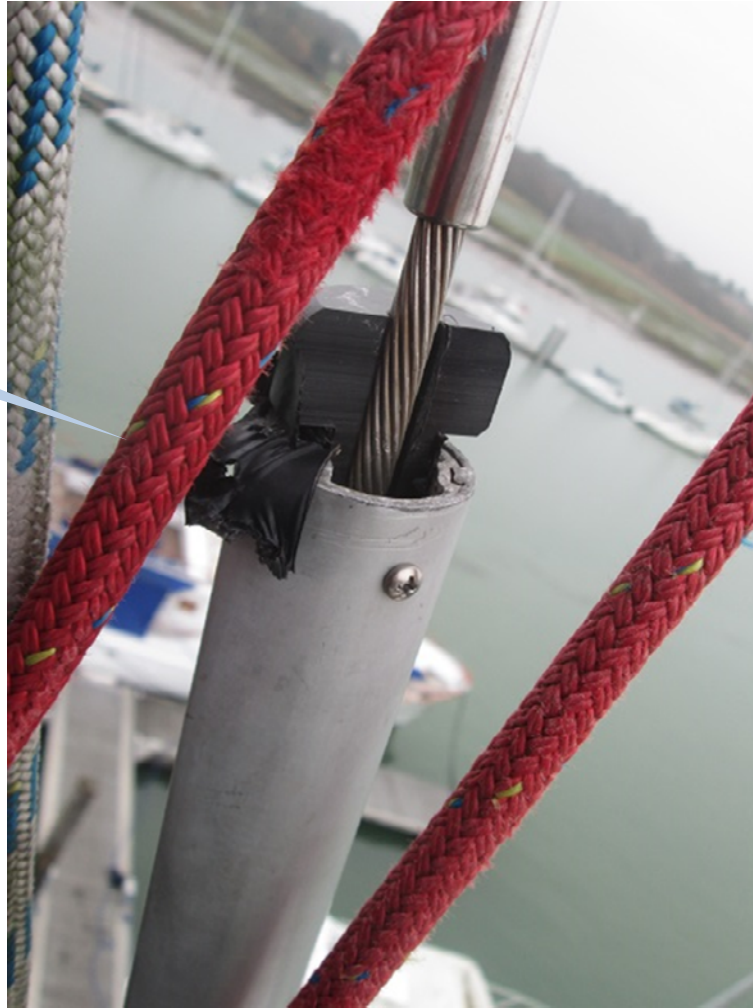
Furling system top
cap half missing

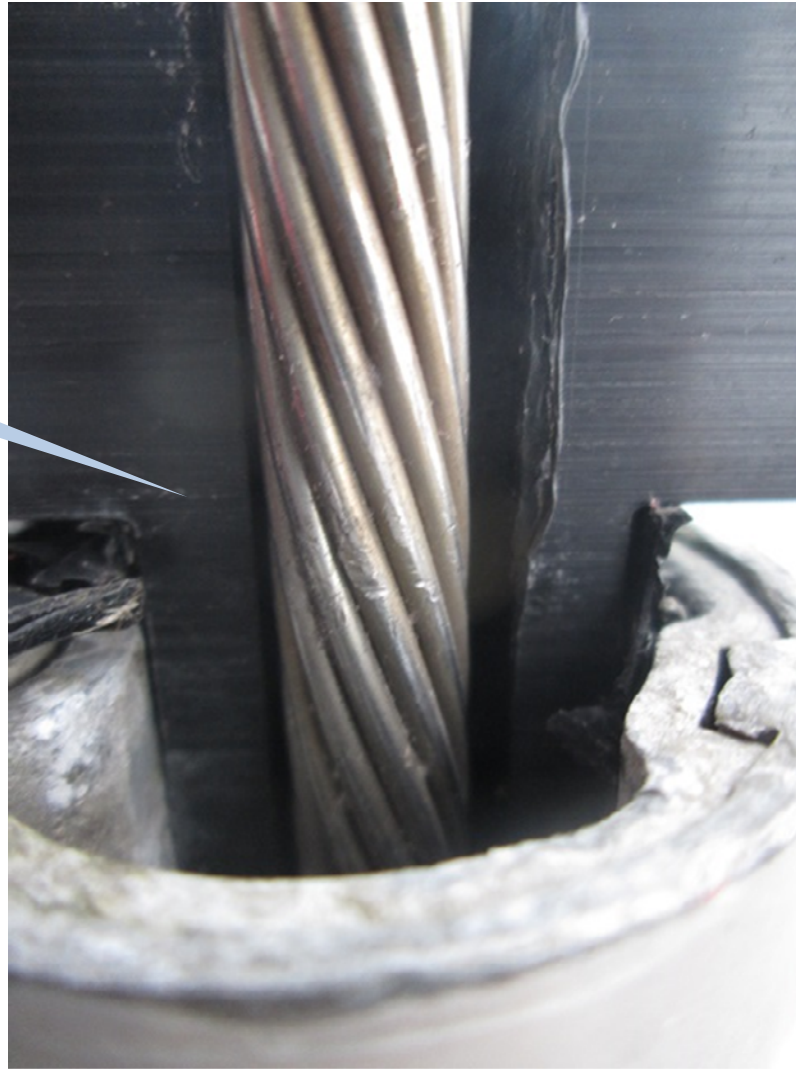
Slight abrasion to
wire surface on top
of furling system

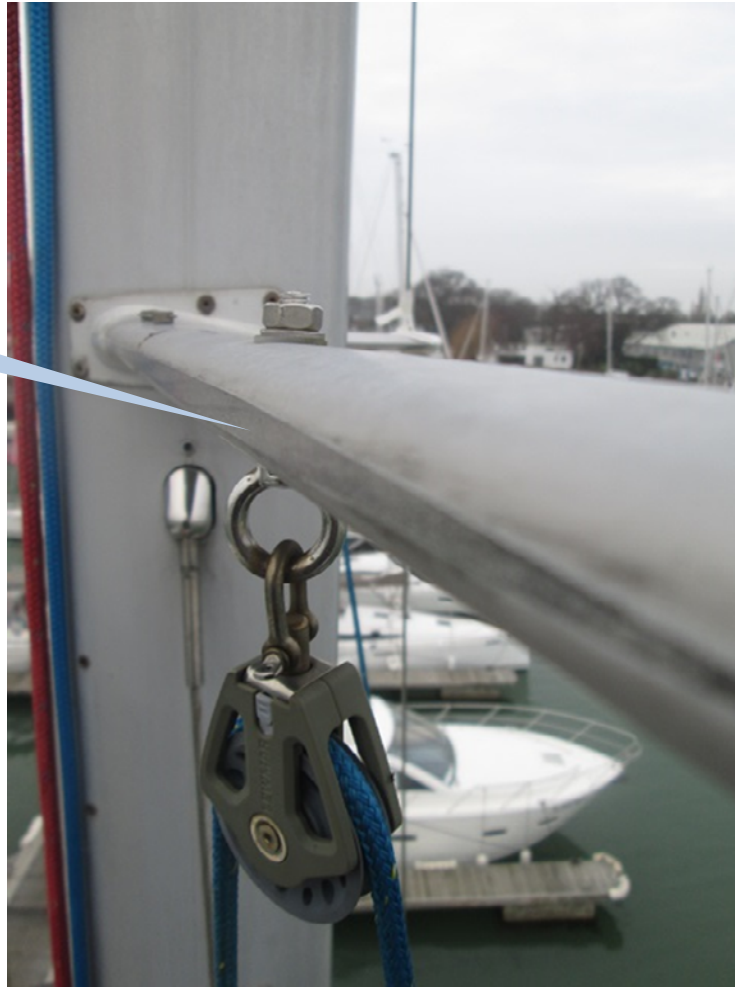
Staysail stay wear to
front of spreader

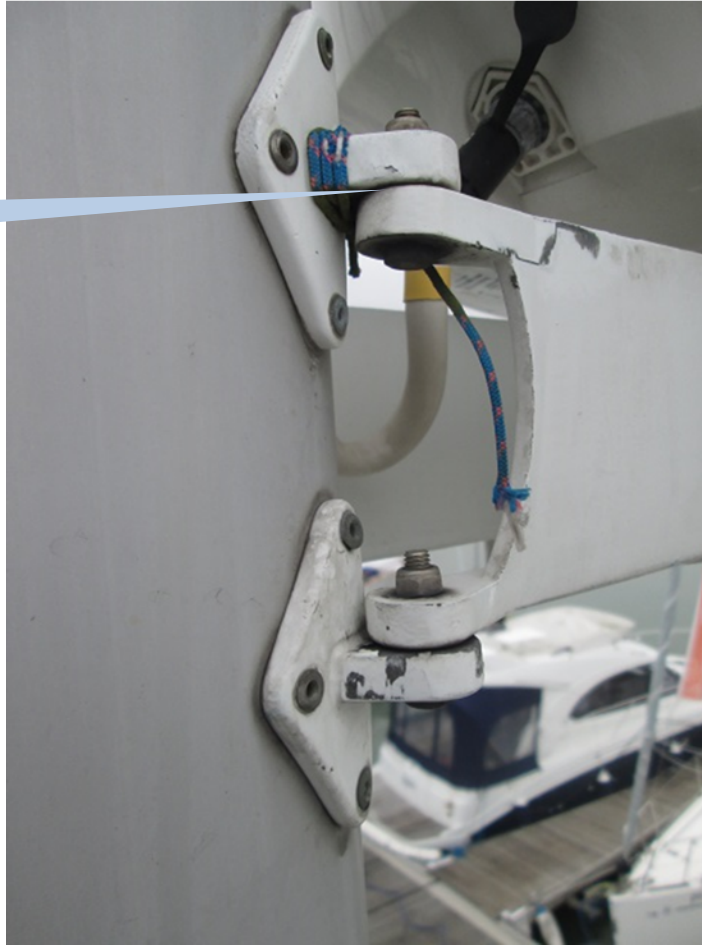
Radar bracket bolt
holes
worn/elongated

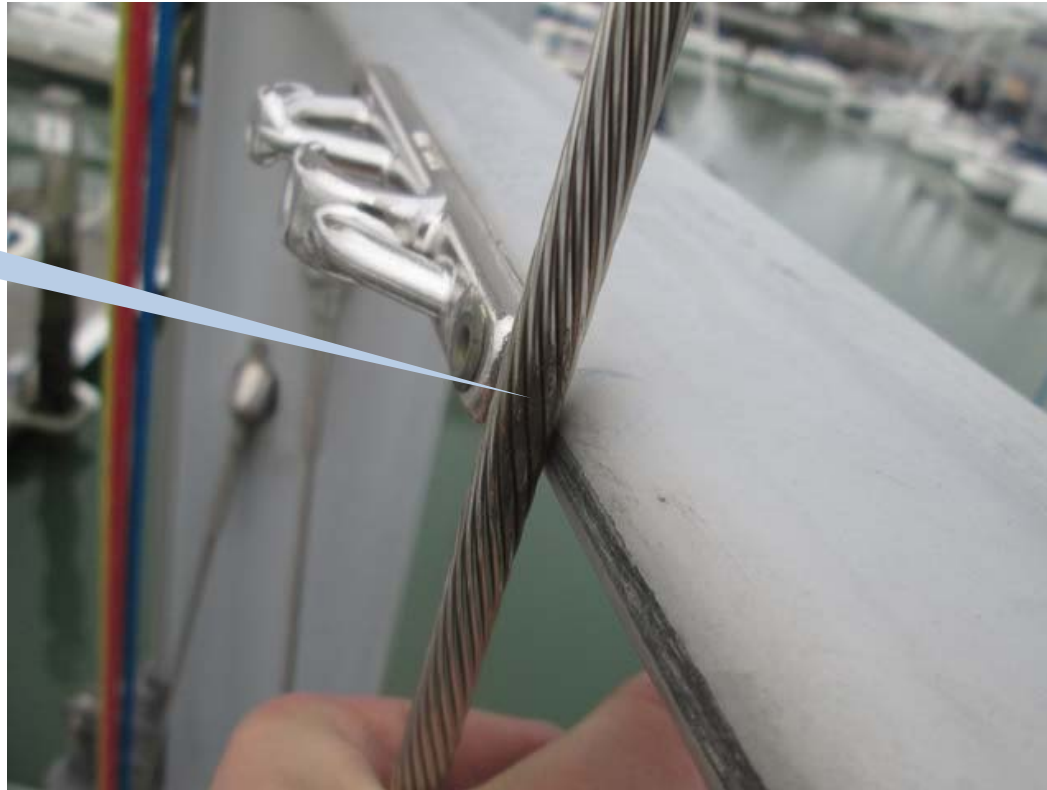
Staysail wire strands
wearing in holder
